# Thermporal: An Easy-to-Deploy Temporal Thermographic Sensor System to Support Residential Energy Audits

CHI 2019 | May 9<sup>th</sup>  
Session on Sustainable HCI

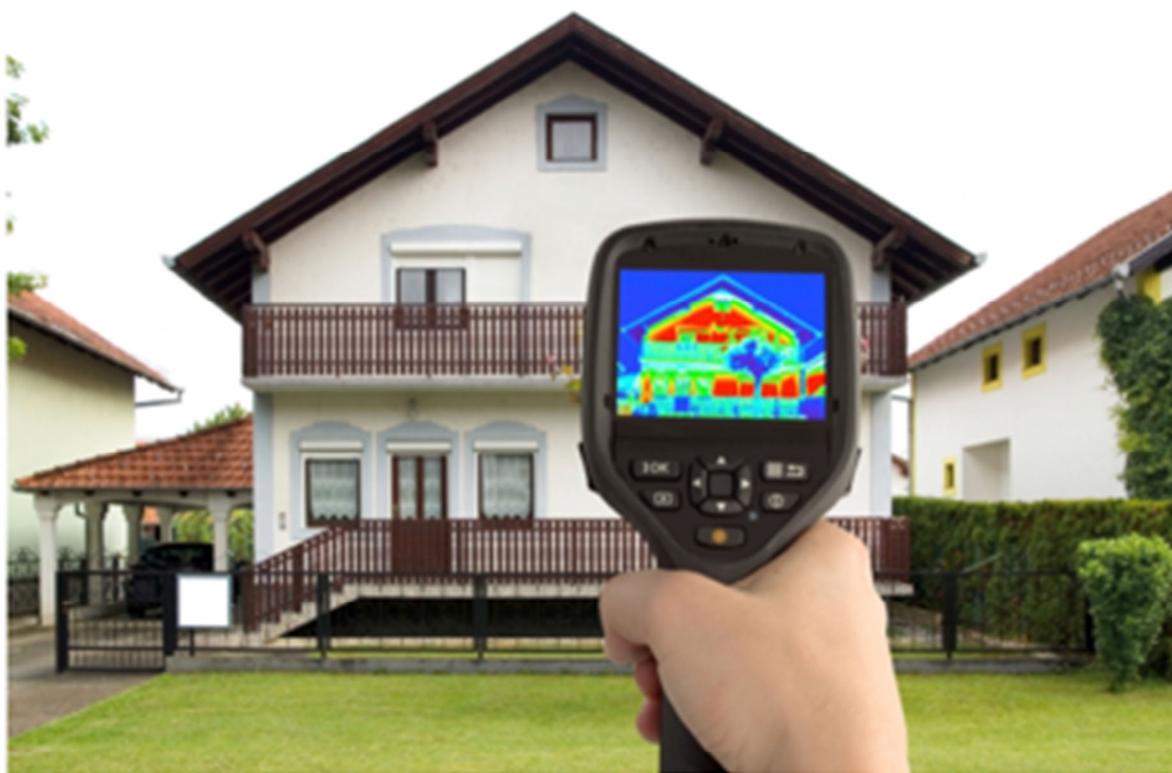
## Thermographic Inspections

Energy auditors may use thermography – or infrared scanning – to detect thermal defects and [air leakage](#) in building envelopes.

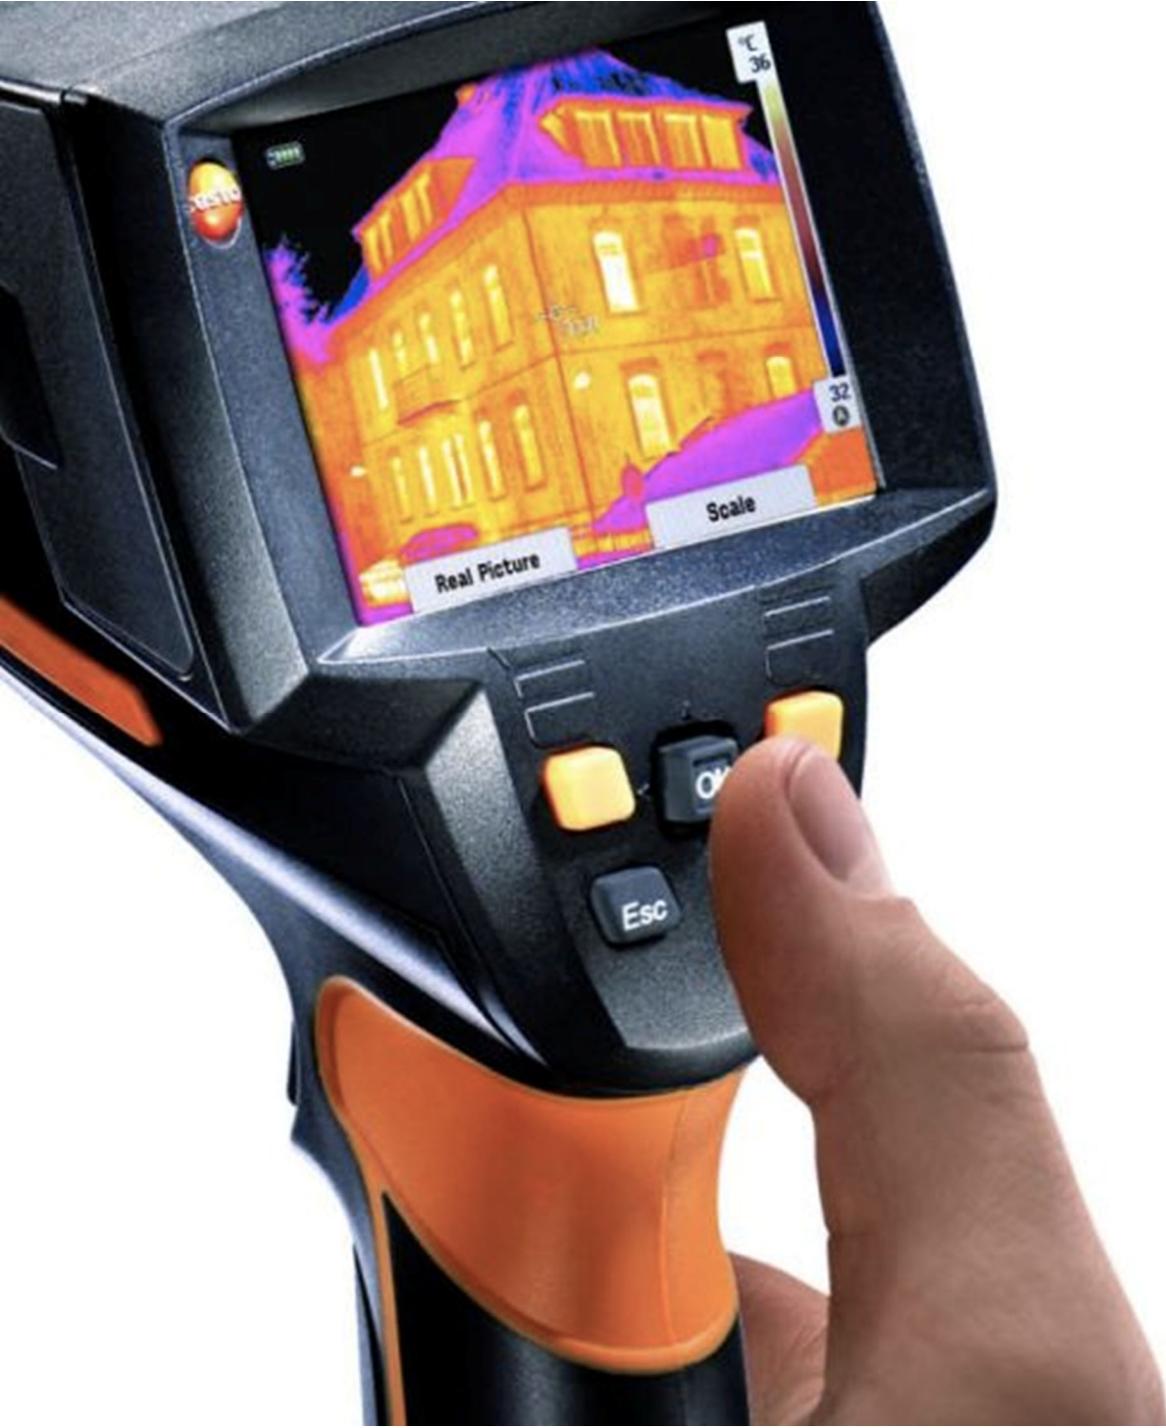
# Thermal Cameras

- Thermal cameras (or infrared cameras) detect electromagnetic radiation with lower frequencies than visible light (*i.e.*, infrared frequencies).
- All objects above absolute zero emit infrared radiation, so thermal cameras can 'see' in the dark without external illumination.
- The amount of radiation emitted by an object increases with temperature, so thermal cameras can also measure heat.

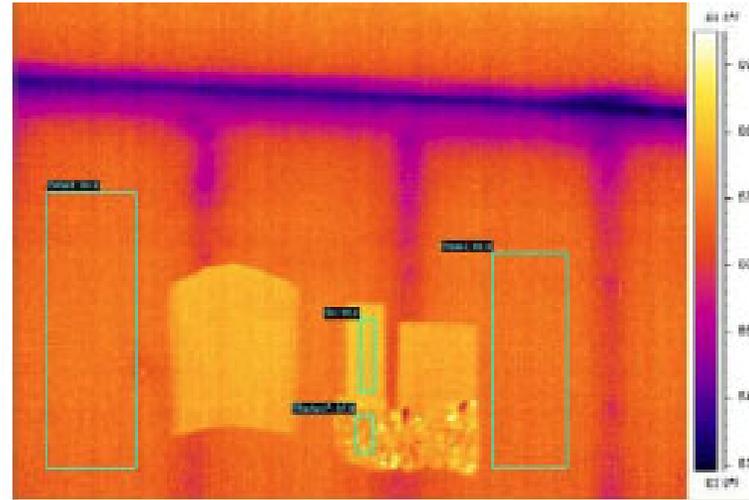
# RELATED WORK: QUANTITATIVE THERMOGRAPHY

$$R - Value = \frac{\Delta T_{io}}{4\epsilon\sigma T_m^3 \Delta T_r + h_c \Delta T_a}$$

**ABSTRACT**  
One can calculate the R-Value for an exterior wall segment by estimating the heat flow between the interior of a room and the interior wall surface. In steady state heat transfer conditions, all the heat that flows to the wall flows through the wall. Quantifying the heat flow through the "air film" near the surface of the wall is a straightforward radiation and convection calculation. One needs to know the indoor, outdoor, wall surface and reflected temperatures and the wall emissivity. One does not need to know the wall construction. The challenge is, especially for well insulated walls, that the difference in temperature between the room and wall surface can be small, sometimes only a degree or two, sometimes even less. Calculations based on small delta-T's can result in large errors. For this work the necessary temperatures were measured with FLIR Systems, Inc. model P640 and P65HS IR cameras and a Davis Vantage Pro 2 weather station every 15 minutes for a 24 hour period for a real world experiment. These measurements were done on different wall segments and different dates. Controlled tests were performed using a P65HS and Extech data logger on a box we call our "inside-out house" comprised of differently insulated stud frame constructed bays with wood studs and standard construction, albeit the height was limited to about four feet. The author developed Excel spreadsheet software to download the series of images and automatically calculate R-Values. For steady state conditions and proper measurement, the R-Value should remain constant. Measurement uncertainties were using the Standard Deviation to Average Value ratio for various measurement techniques and weather conditions for both the real-world home and our inside-out house. The best consistency was 2% to 5% for a controlled environment with a real world variation of 7% to 12%. The author performed an uncertainty analysis to evaluate the sensitivity of R-Value calculation to the variables involved. The paper discusses measurement techniques and procedures, weather conditions and interior conditions that will minimize the error of estimating R-values using IR thermography.

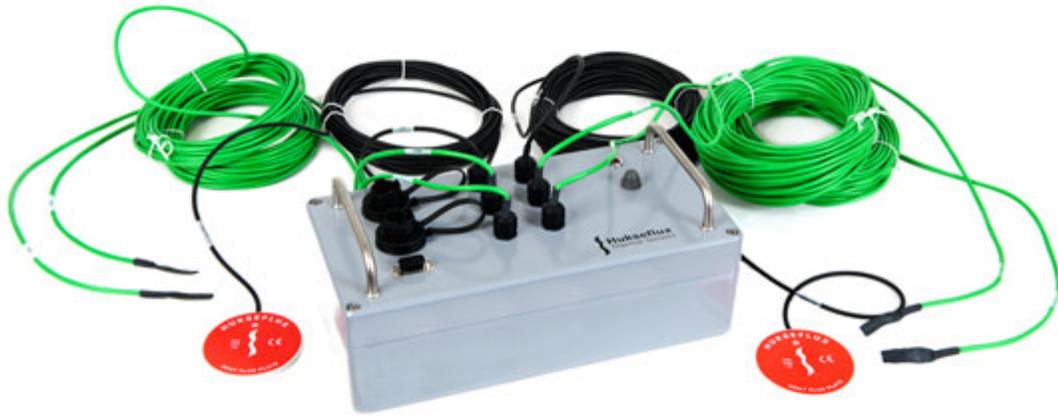
Direct Contact Methods:  
Heat Flux Sensors and Thermocouples

## RELATED WORK: QUANTITATIVE MEASUREMENT

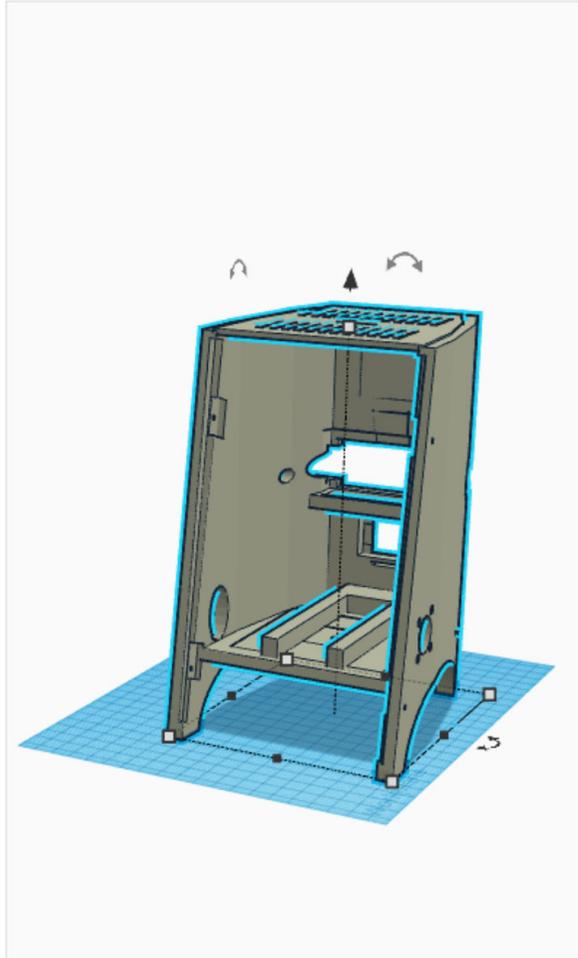
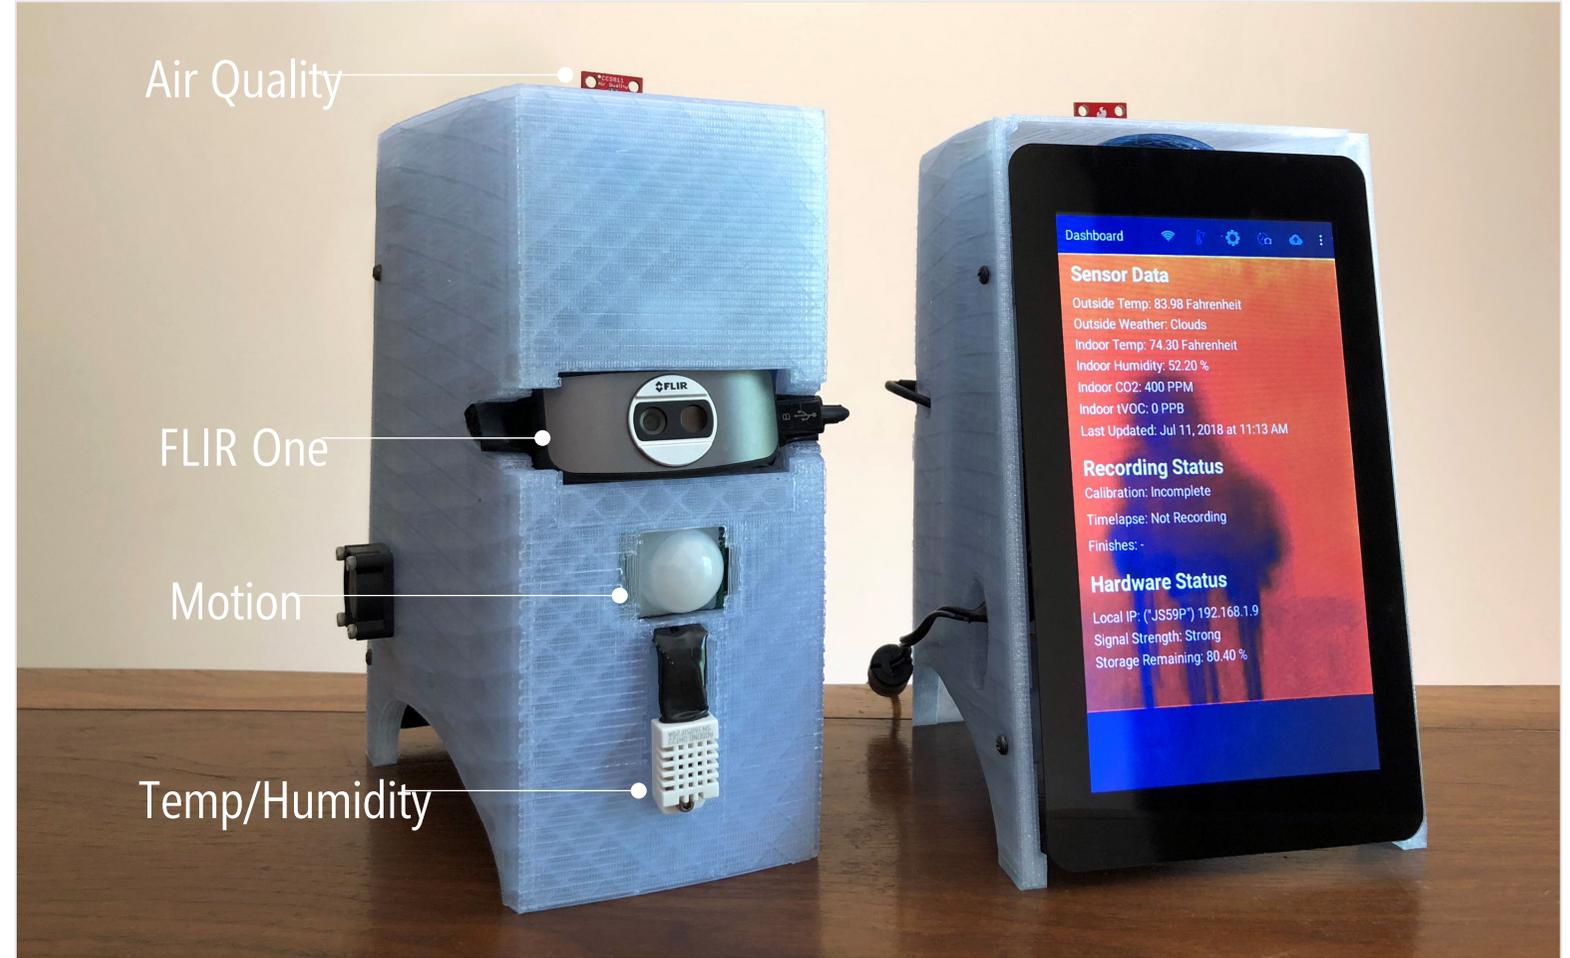
# DEVELOPMENT: EASY-TO-DEPLOY THERMOGRAPHIC SENSOR KIT (v4.0)

Once WiFi is connected, the system constantly collects: Outdoor Weather, Outdoor Temperature, Indoor Temperature, Indoor Relative Humidity, Motion, and Air Quality Data (e.g., CO2, TVOC).

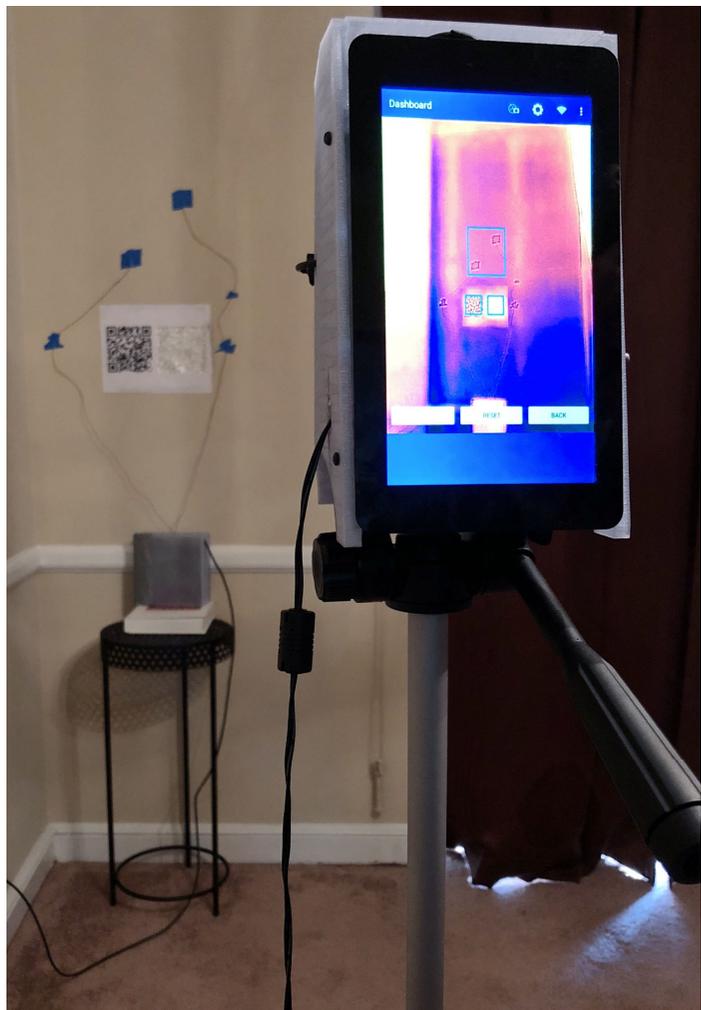
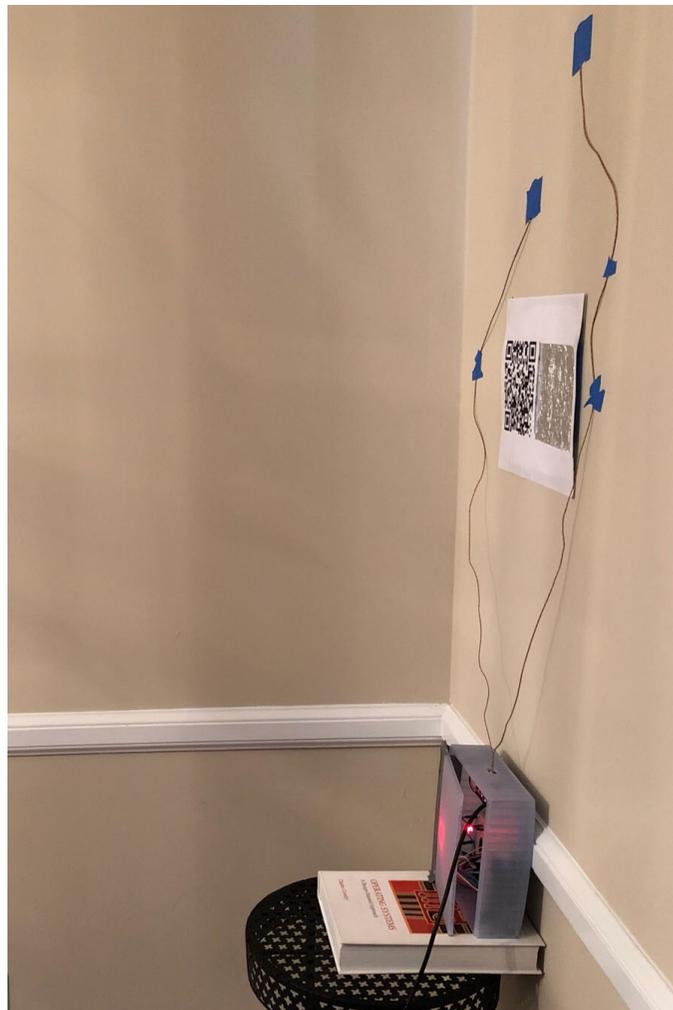
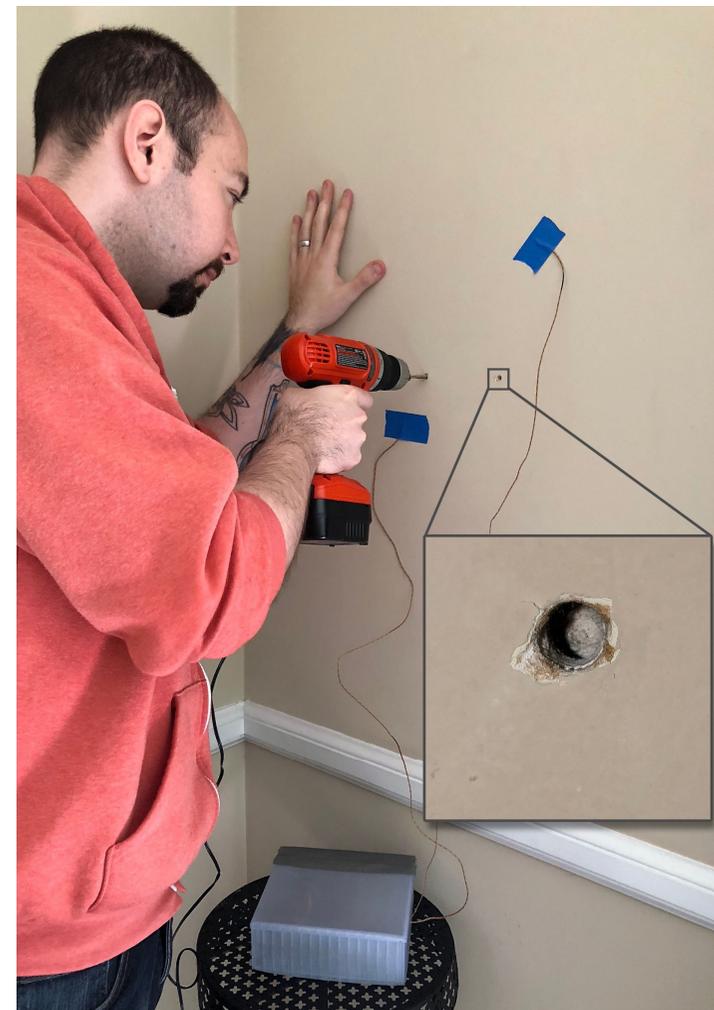
# DEVELOPMENT: VALIDATION EXPERIMENTS

<b>Data Segment</b>	<b>Notional</b>	<b>THM (deviation)</b>	<b>IRT (deviation)</b>	<b>Average Temp. Delta</b>
Day 1	R-6.50	R-7.54 (16.00%)	R-7.67 (18.00%)	27.47°C
Day 2	R-6.50	R-6.67 (2.61%)	R-6.29 (3.23%)	20.96°C
Full Campaign	R-6.50	R-6.30 (3.07%)	R-6.39 (1.69%)	22.85°C

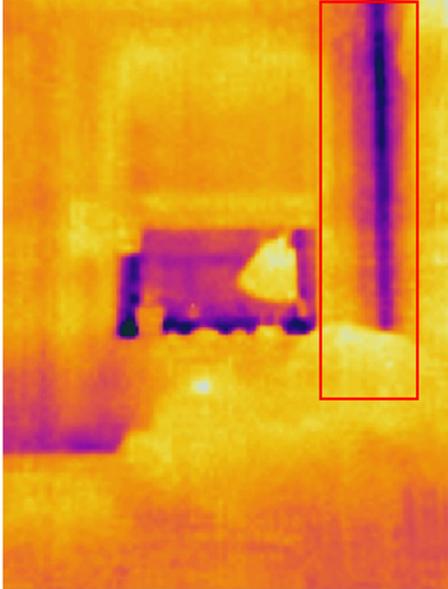
Thermal Analysis of [Wall (Non-Baseament)] Performance

**13.00 R | OKAY**

**Data Collection Results:**  
The performance of the insulation in the highlighted region appears to be **within the typical recommended insulation range of 13 - 20 R** that is common to this region of the United States; 20 R is standard for an insulation cavity, but thermal bridges (e.g., studs) and degradation can reduce overall performance.

**What To Look For:**  
Any regions in the image that appears brighter than the highlighted region are likely performing better, while regions that appear darker are performing worse (assuming winter-like weather conditions). If brighter or darker regions appear around windows or doors, this could be an indication of an issue with the way the window or door was installed or could indicate the presence of an air leak.

**Potential Recommendations:**  
By adding or improving insulation and reducing air leakage around windows and doors, you could potentially save between 10 - 15% on your monthly utility bill and improve thermal comfort in your home. If, upon reviewing this thermal image, you notice more low performing areas than similar or higher performing areas you may want to consult your building manager, facilities management staff, or an energy auditing professional.
